## 3.0 Character Appraisal

### 3.5 Character - Existing Site

## 4.0 Design Process

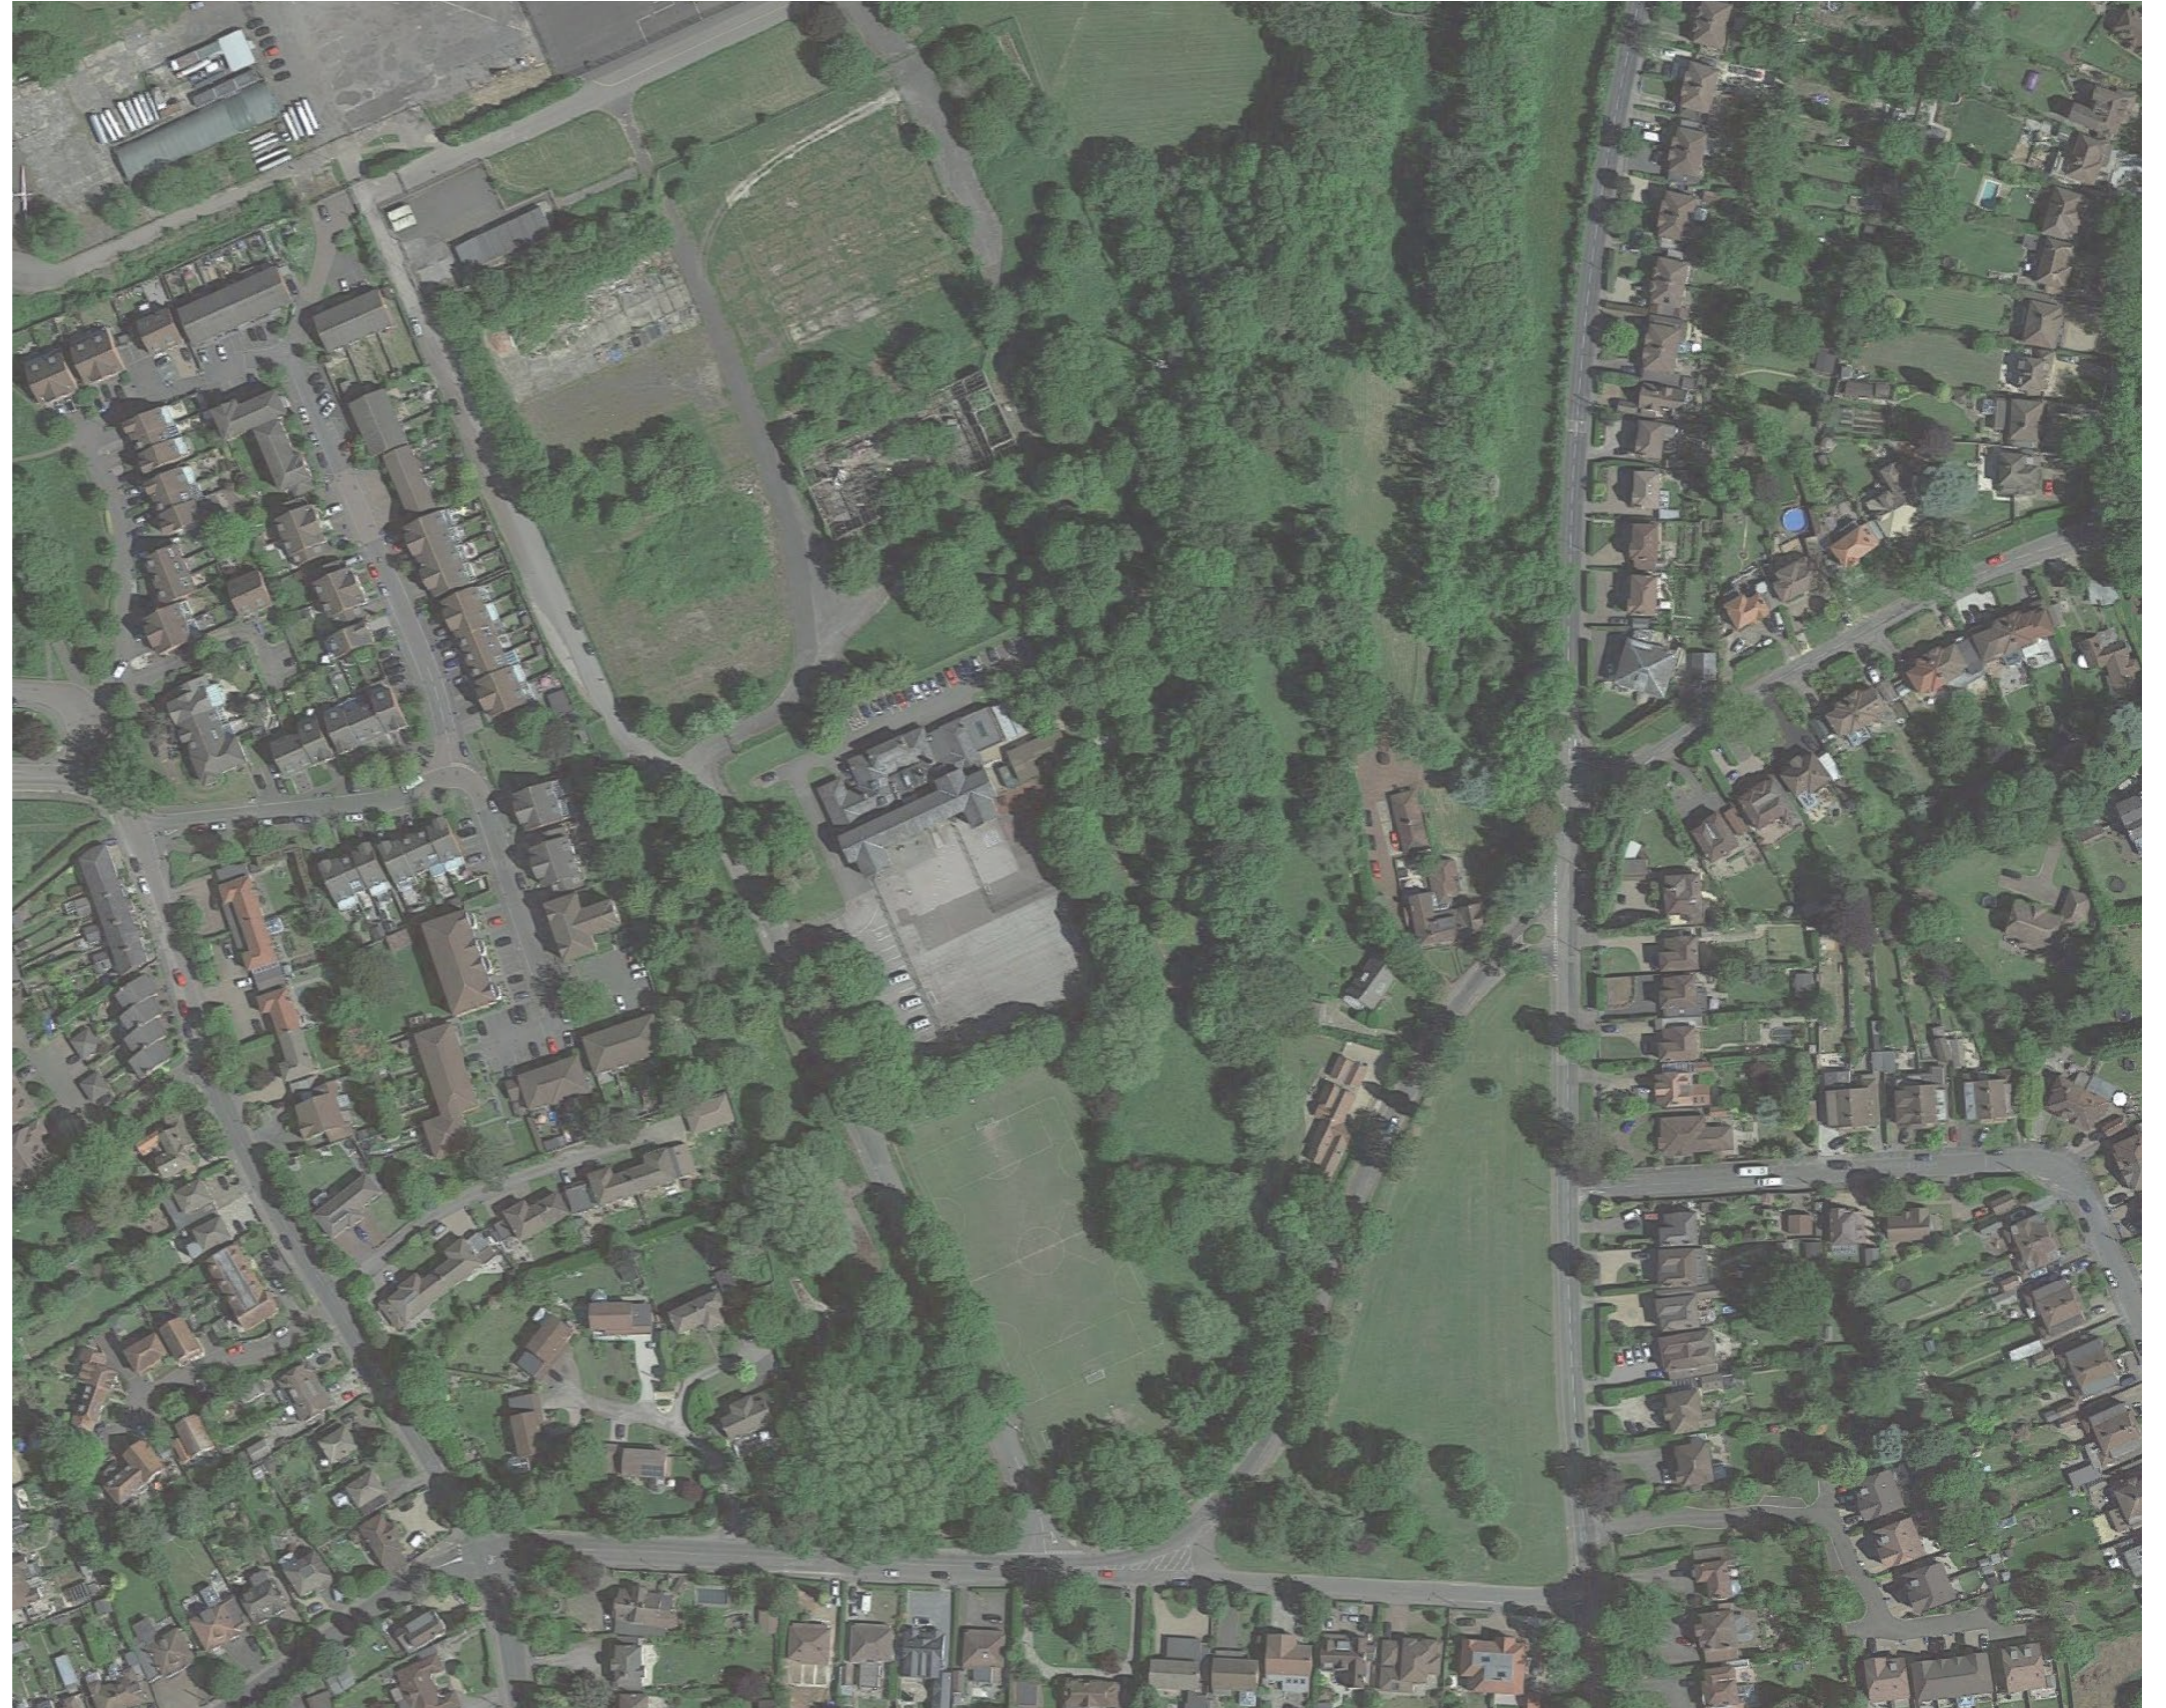
### 3.9 Existing Aerial

The existing aerial view illustrates the nature of the wooded and post-war clearance setting. The hardstanding areas are evident to the north and scrub, interspersed with pockets of mature and self-seeded trees define the overall character of the site and its perimeters.

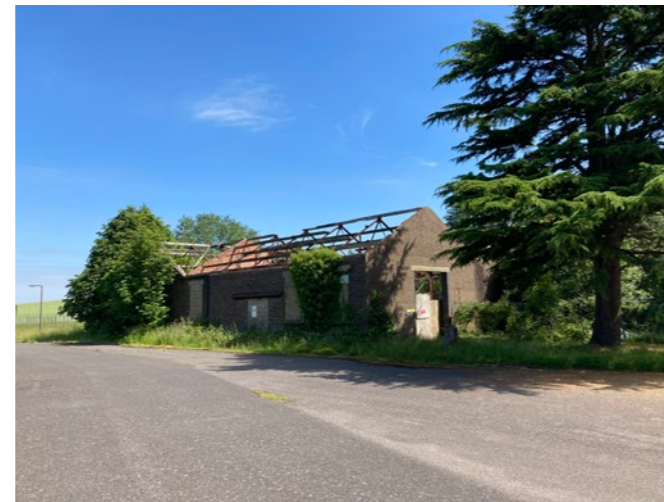
View of derelict former workshops

The existing workshops on the northern site are now derelict and will be demolished to provide a cleared site for consideration. The trees on site are therefore the key constraint to assess in order to consider residential proposals on the site(s). The site is currently subject to a "Blanket Tree Preservation Order"

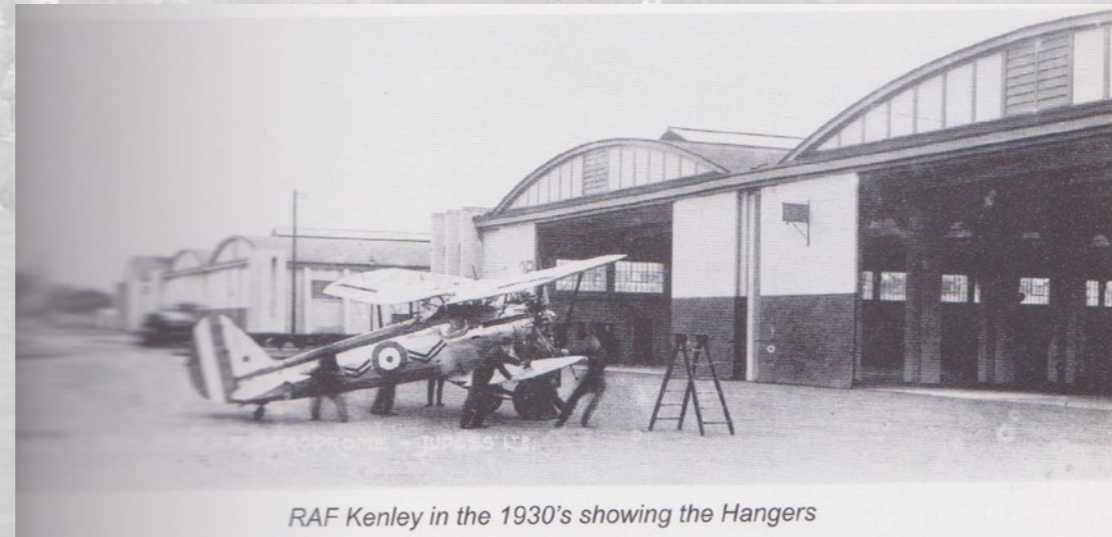
RAF Kenley in the 1930's showing the Hangers

To the north of the Institute, a series of hangars and workshops lead to the aerodrome to the north. Only a single derelict Workshop building survives within this area today. Both elements of the site are situated within the Kenley Aerodrome Conservation Area, designated for its retained military character and surviving aerodrome with associated blast pens.

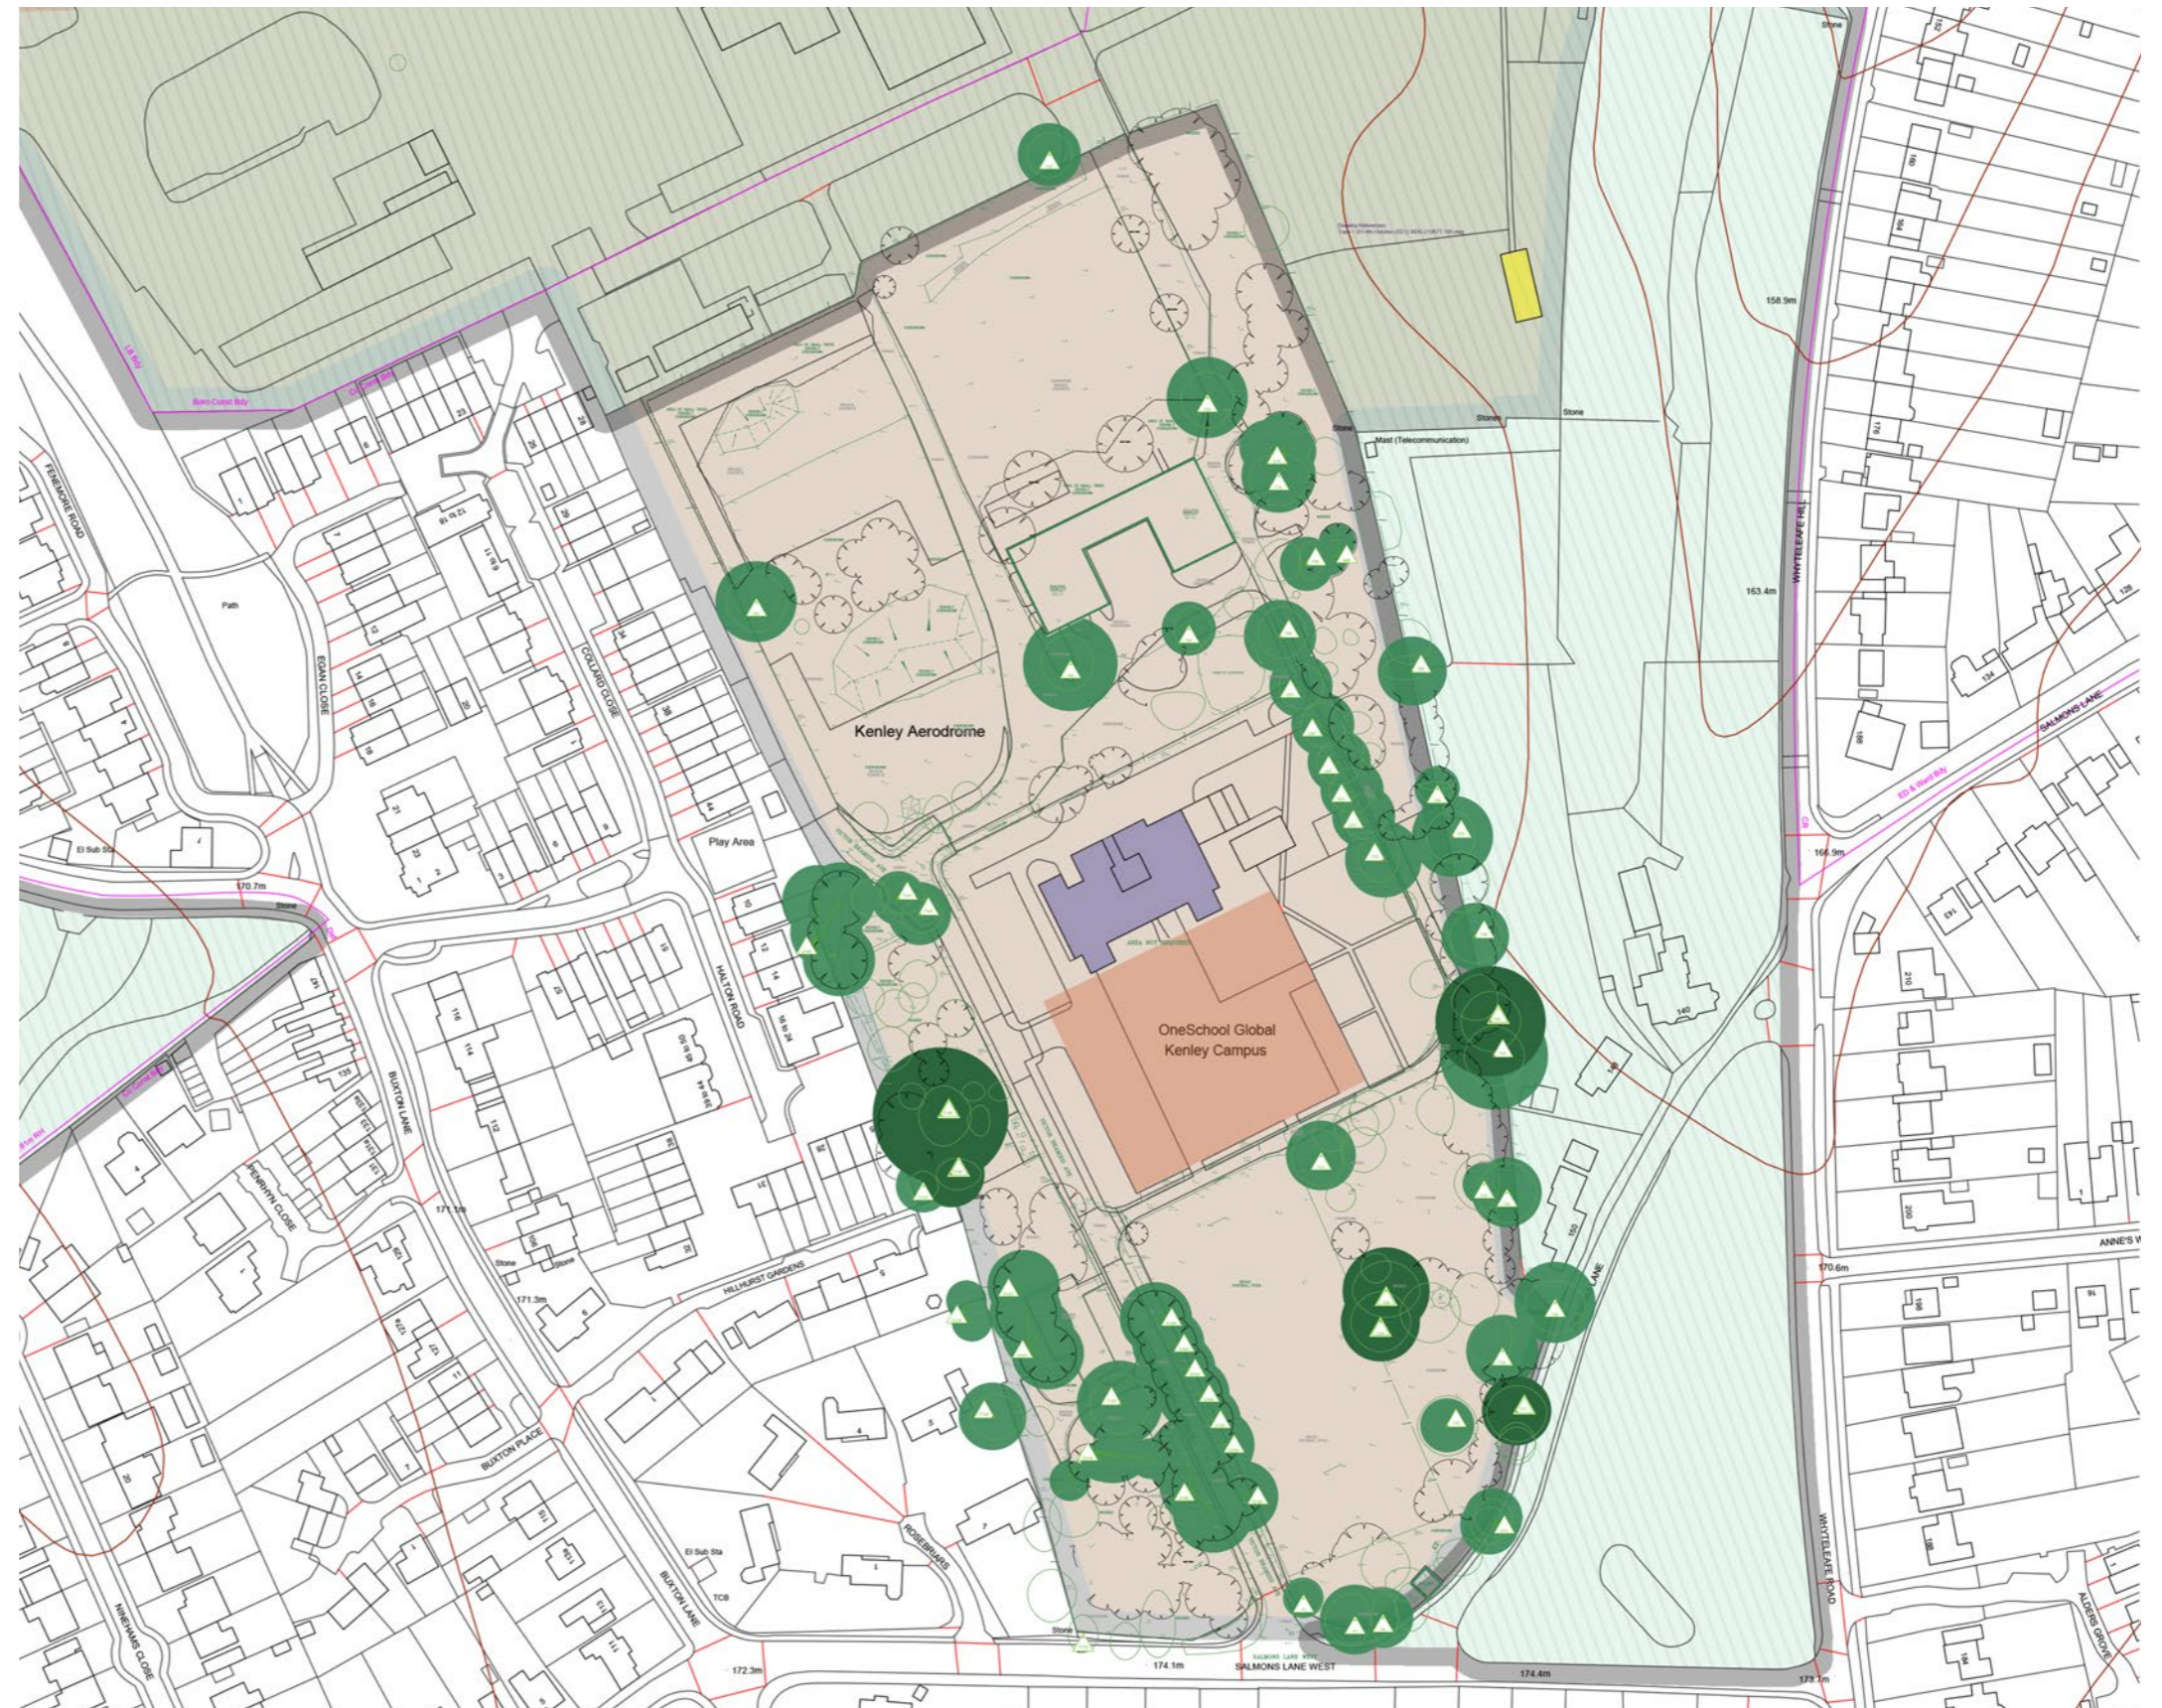
Guided by the Landscape Framework, the site has been surveyed and a comprehensive Arboricultural Assessment produced on topographical base as a basis to consider proposals.

Most of the significant boundary tree cover is being retained, and none of the lost trees are prominent as skyline features in the wider setting. Their loss will be noticeable in the immediate vicinity immediately after the development is completed, but the comprehensive new landscaping proposals will rapidly mitigate those losses and limit the impact on local character to the short term and in the immediate vicinity. There will be no adverse impact to local character in the wider setting in the long term.

There is space for tree planting and a landscaping scheme will be feasible in response to an appropriate condition. The construction activity has the potential to adversely affect retained trees if proper protective measures are not taken. However, if adequate precautions to protect the retained trees are specified and implemented through the arboricultural method statement included in this report, the development proposal will have no detrimental impact on the contribution of trees to local character.
