Daniel Watney LLP

Kenley Campus, Caterham, Surrey

*Desk Study, Geotechnical and
Geoenvironmental Interpretative
Report*

February, 2023

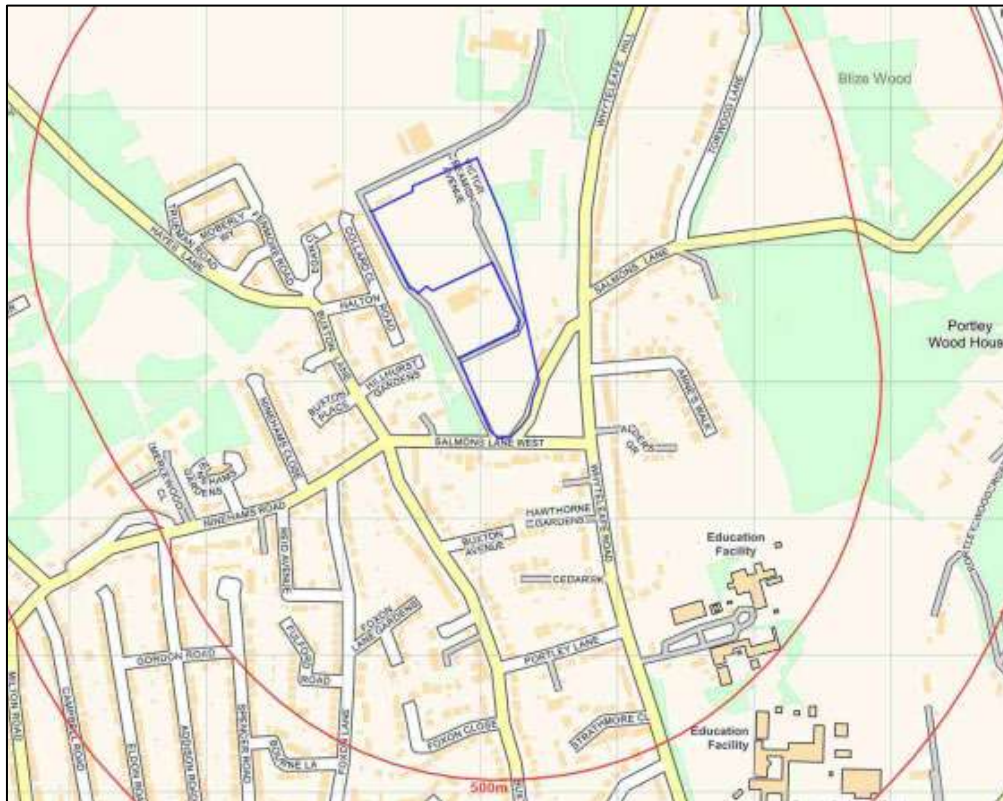
Plate 6: An excerpt from a 1:10,000 map from 2022

From c. 1974 new housing was constructed 250m northwest in the form of *Anson Close* and *Quantlet Crescent* shortly after which (from c. 1992) most of the buildings on site were demolished with the exception of the listed structure in the north of the site. From c. 2010 further housing was constructed 50m northwest of the site and between 2010 and 2022 the building to the north of the *Parade Ground* was converted into a school. Some of these developments are shown in an extract of the 2022 ordnance survey map in Plate 6.
