**Kenley Campus, Victor
Beamish Way**

SuDS Strategy

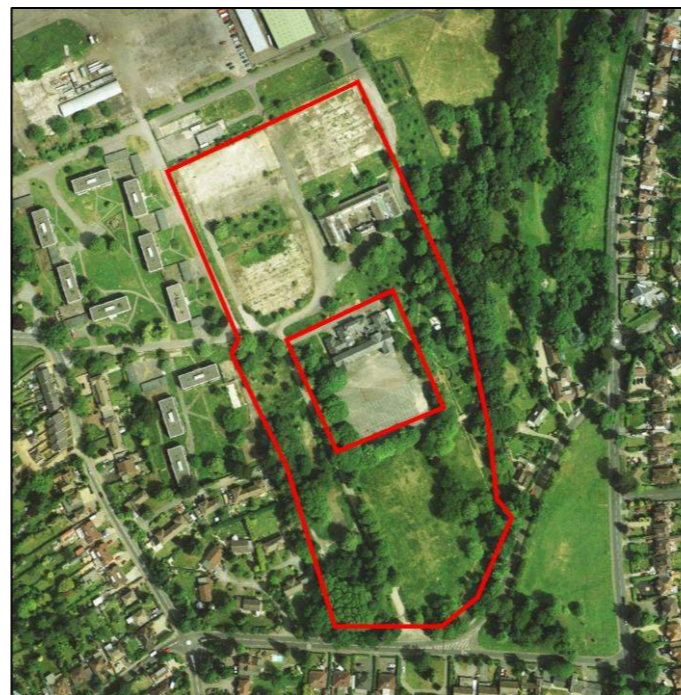
Figure 2: Historical mapping of the site.

Historical imagery from 2003 (found in figure 2) shows the extents of hard surfacing prior to overgrowth which is seen in more recent imagery. The southern part of the site is currently used as a sports field.

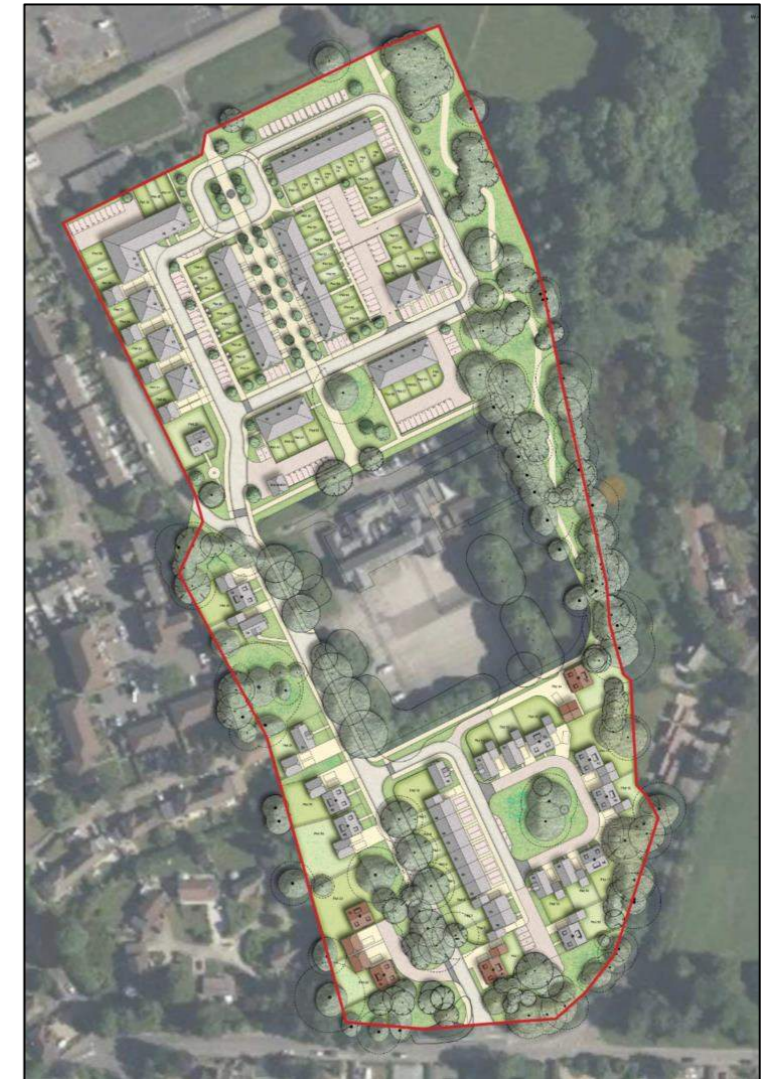
Figure 6: Proposed Site Layout

The proposed development will consist of the construction of 87 homes, with associated gardens, roads and driveways and landscaping areas.

An extract of the proposed development can be seen below as Figure 6 with more detailed plans in Appendix C.

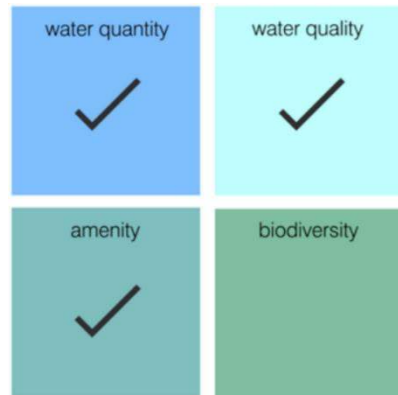
Figure 8: Permeable Paving Performance

Permeable surfaces will be used for the proposed residential roads and parking bays throughout the site. The surfaces will be designed to infiltrate to ground where possible with overflow connection into the deeper sitewide drainage system.

Permeable surfaces provide high mitigation indices and provide water quantity, water quality and amenity benefits.

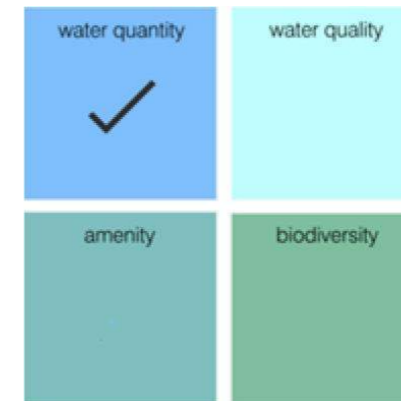
Figure 11: Tank Systems Performance

The tanks have been sized to manage surface water for all storm events up to and including the 1 in 100 + 40% climate change. All surface water will be routed towards these below ground attenuation tanks before discharge to ground via the deep bore soakways.

Tank systems provide water quantity improvements.
